Manhole Inspection Summary

Manhole # S33AA1010MH

Insp Date: **4/3/07 3:35 PM**

Location Address: **JOHN HOPKINS COLLEGE**

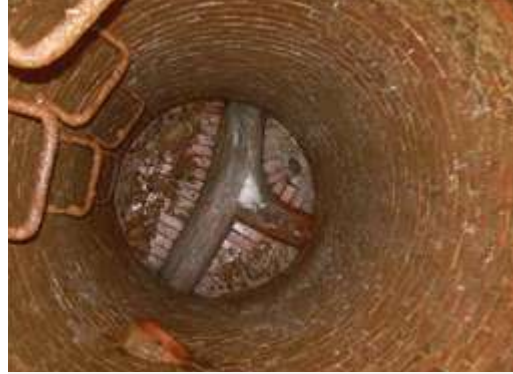
Top View

Corroded steps. Bench debris.

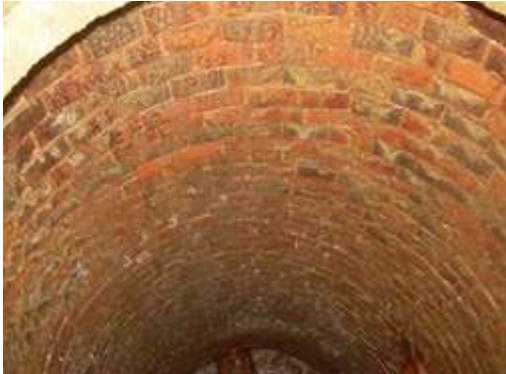
Defect

Frame leaks. Adjustment infiltration.

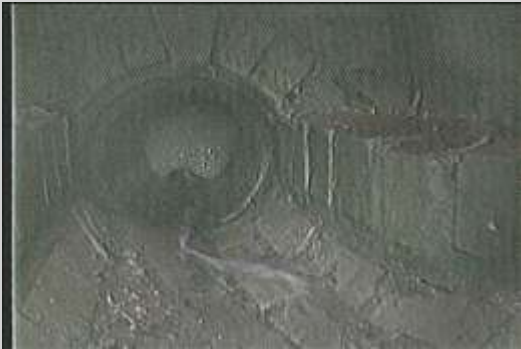
10 in. Circular Gravity Sewer Pipe Out @ 12 O'Clock

Infiltration: **Evidence** Pipe Seal Cond: **Unknown**

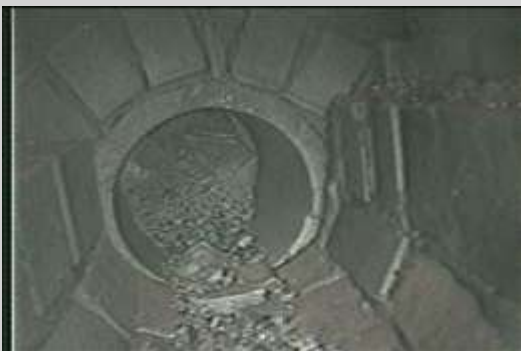
Pipe In @ 3 O'Clock

PLUGGED

Connects To: **Stub connection / abandoned**

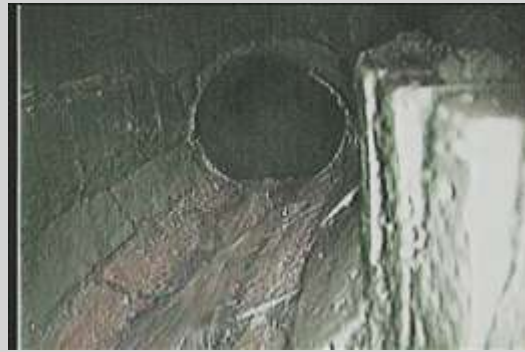
Drop In @ 7 O'Clock

Drop: **Outside** Rod and Bar

Drop Condition: **Open**
